Project Title: Riverview Sobeys, Retaining Wall Rehabilitation

Client: Sobeys

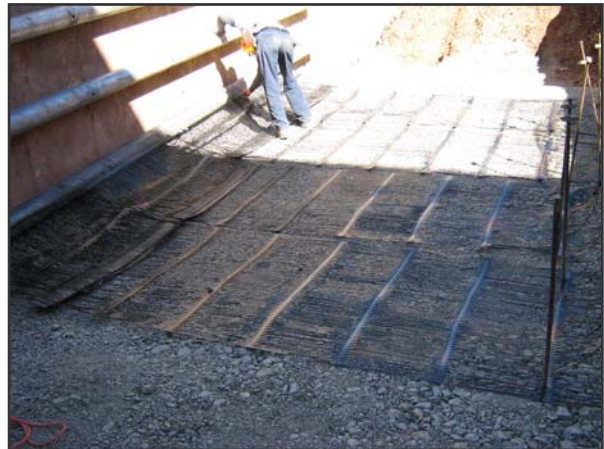
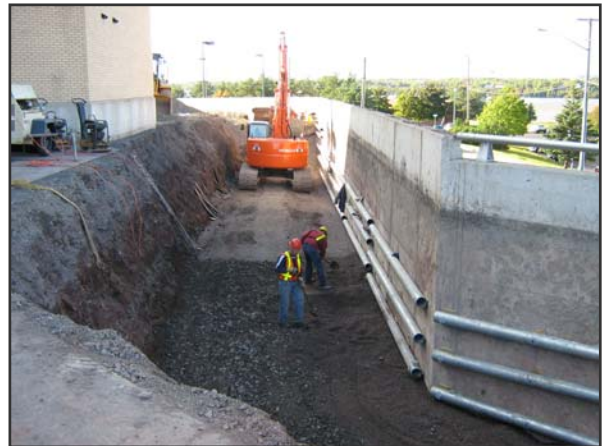
GEMTEC was retained by Sobeys to investigate a failing concrete gravity retaining wall in Riverview. Our investigation revealed that about 80 metres of retaining wall showed signs of excessive outwards movements, which were as much as 250 mm (\pm). A test pit was excavated behind the wall and revealed that the connection between the concrete wall and base foundation had failed.

GEMTEC Limited designed a tied back system to prevent future wall movements. Our design consisted of:

- Removing the silty fill soils behind the wall down to the concrete base foundation
- Backfilling excavation with 75 mm minus crushed rock subbase
- Placing six layers of geogrid reinforcement within the 75 mm minus crushed rock layer at predetermined locations.
- Mechanically connecting the geogrid reinforcement to the wall using a 6" diameter galvanized steel pipe anchored to the wall.
